Building name: Petrobel in Capital City

*Field diagnosis of water penetration of curtain  
walls at Petrobel in Capital City, Egypt  
In accordance with AAMA 501.2-15*

**Subject: “Evaluation of curtain wall systems against water penetration in  
accordance with AAMA 501.2-15 standard”**

# *Evaluation of Curtain Wall system against air leakage at*

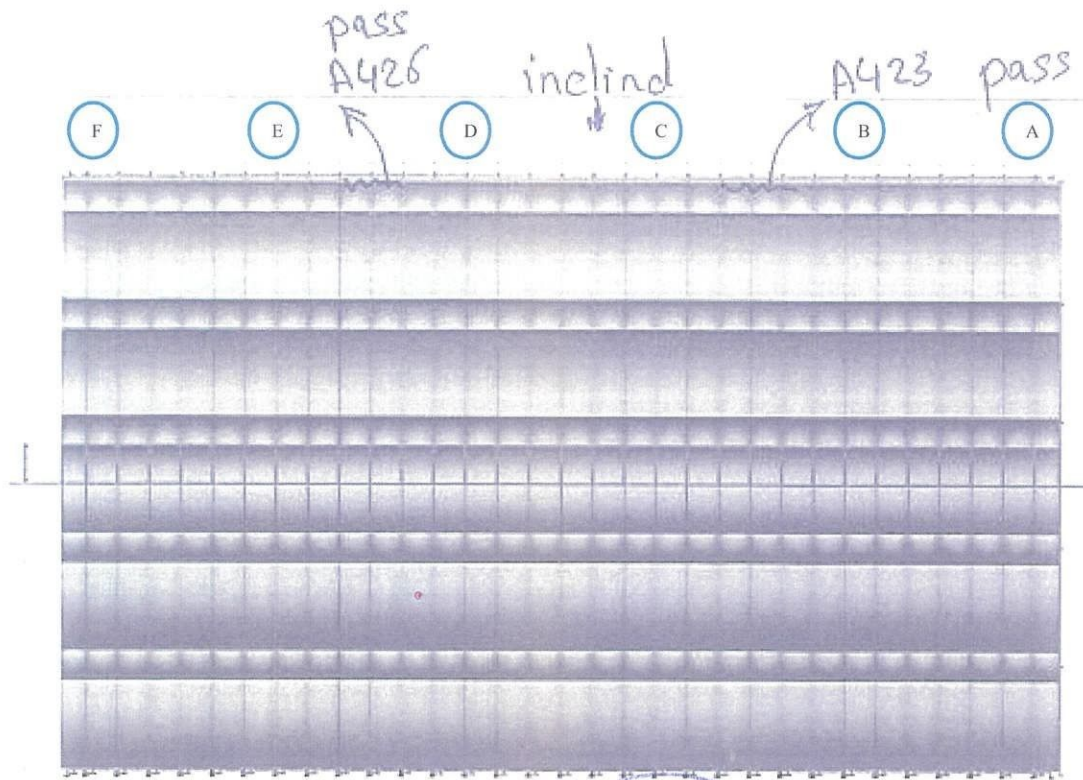
Building A (Straighten side)

| Building | Elevation/roof | Floor | Position (axis) | Room No. | Results |
|---|---|---|---|---|---|
| A | Straighten | 4 | E-D | 426 | Pass |
| | | | C-B | 423 | Pass |
| | | | D-C | inclined | Pass |

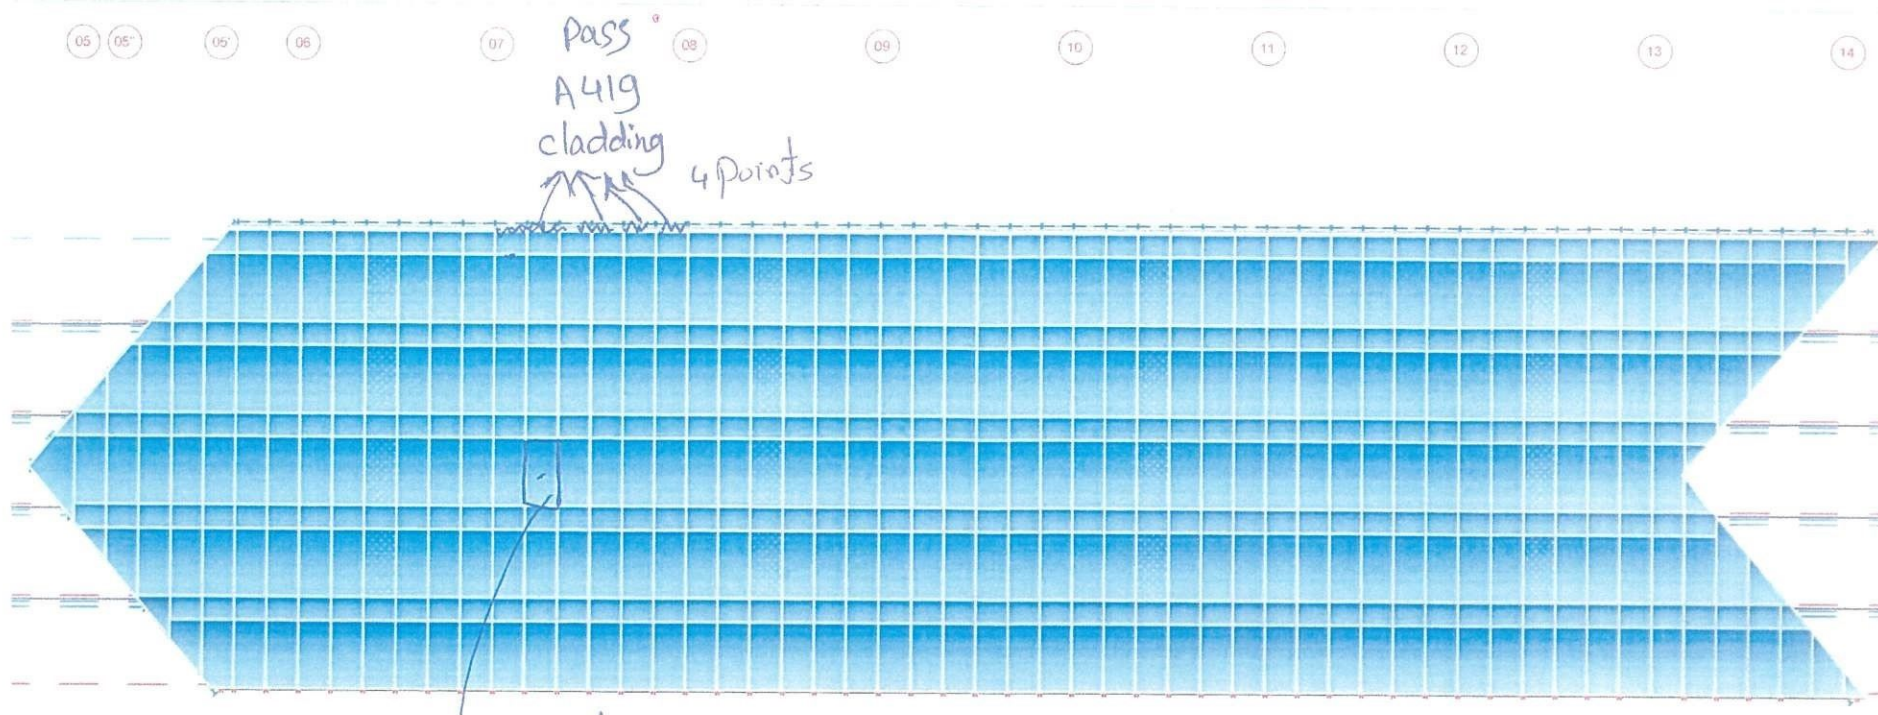
## Building A (Front view )

| Building | Elevation/roof | Floor | Position (axis) | Room No. | Results |
|---|---|---|---|---|---|
| | Front | | 7-8 (cladding) | 419 | Pass |
| | | | 7-8 (cladding) | | Pass |

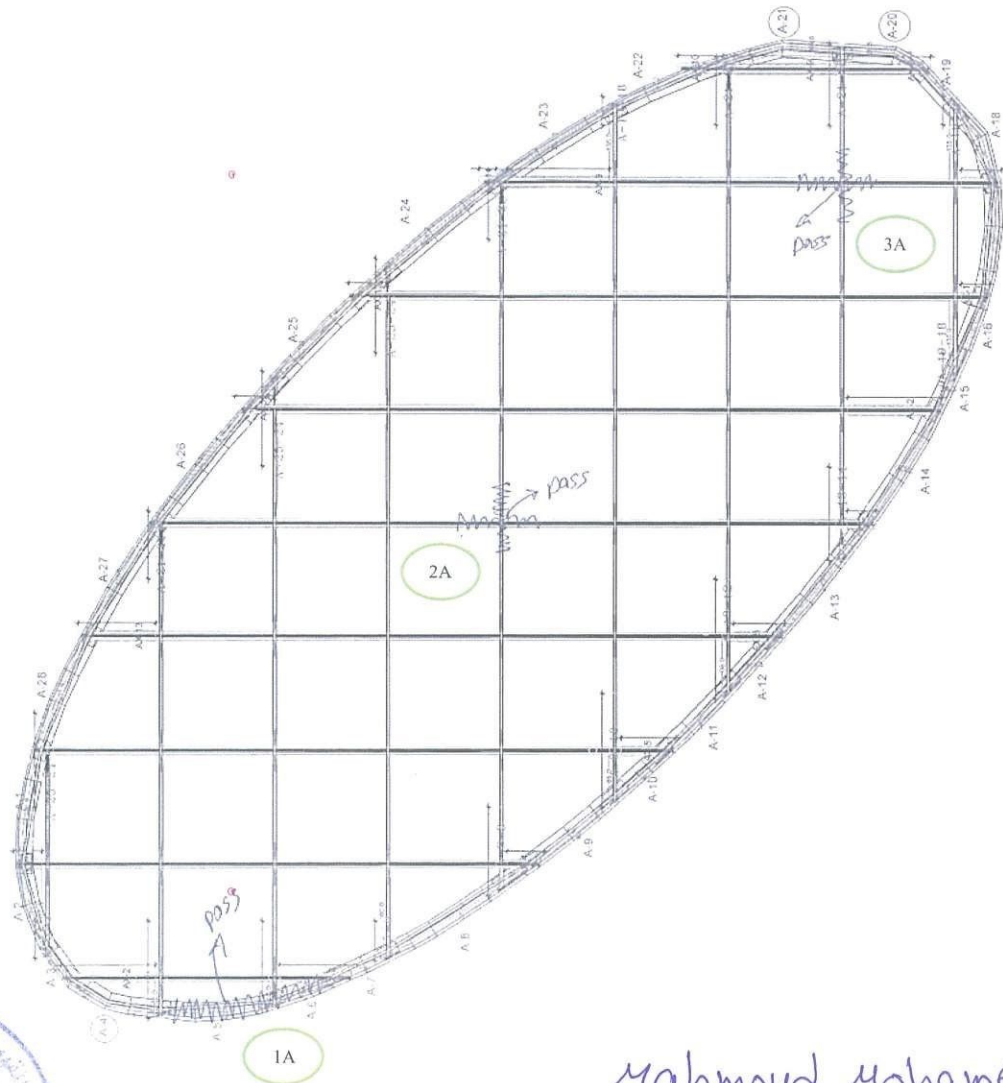
## Building A (Skylight view)

| Building | Elevation/roof | Floor | Position (axis) | Room No. | Results |
|---|---|---|---|---|---|
| | Sky light | Perimeter | 1 A | - | Pass |
| | | Intersection | 2 A | - | Pass |
| | | | 3 A | - | Pass |

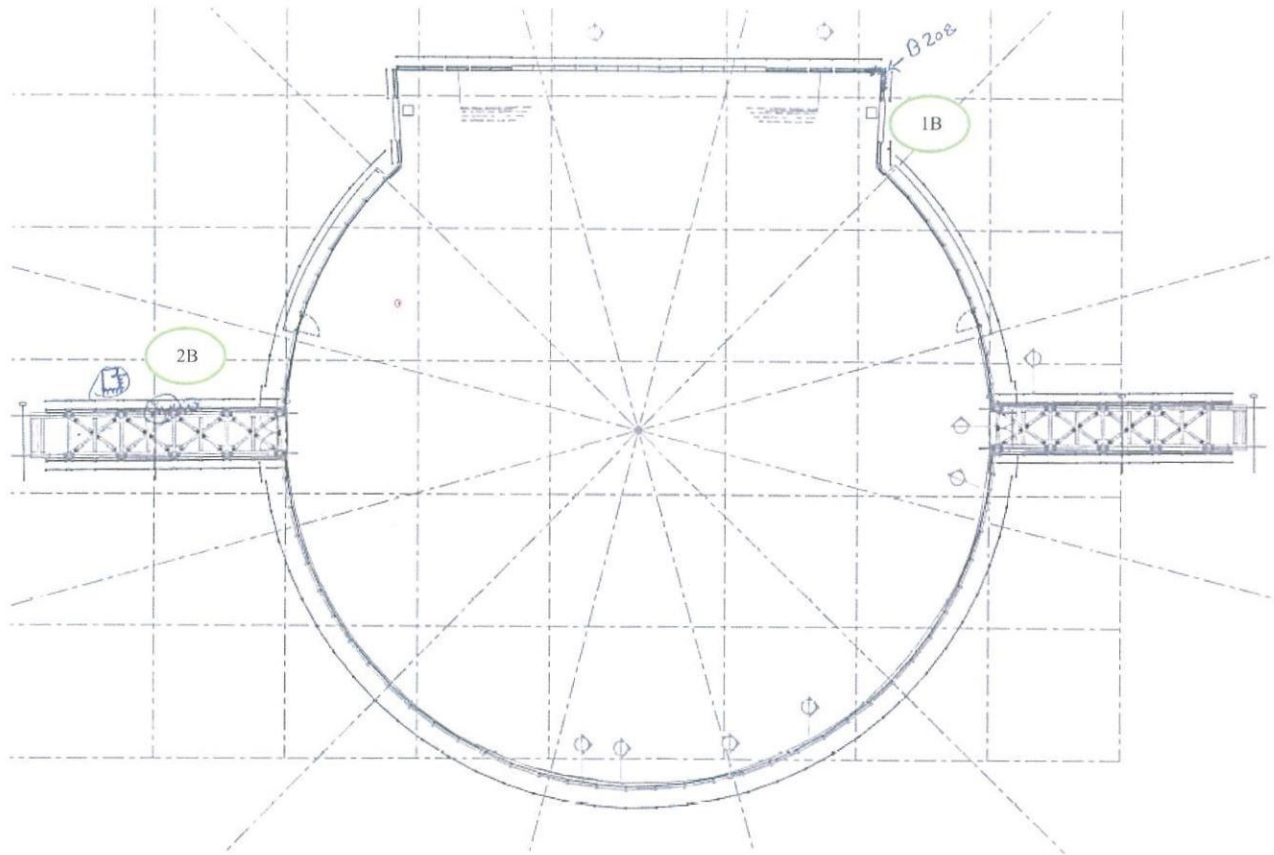
## Building B (2nd floor)

| Building | plan/roof | Position (axis) | Room NO | Results |
|---|---|---|---|---|
| B | 2 <sup>nd</sup> floor | 1B | 208 | Pass |
| | | 2B | - | Pass |

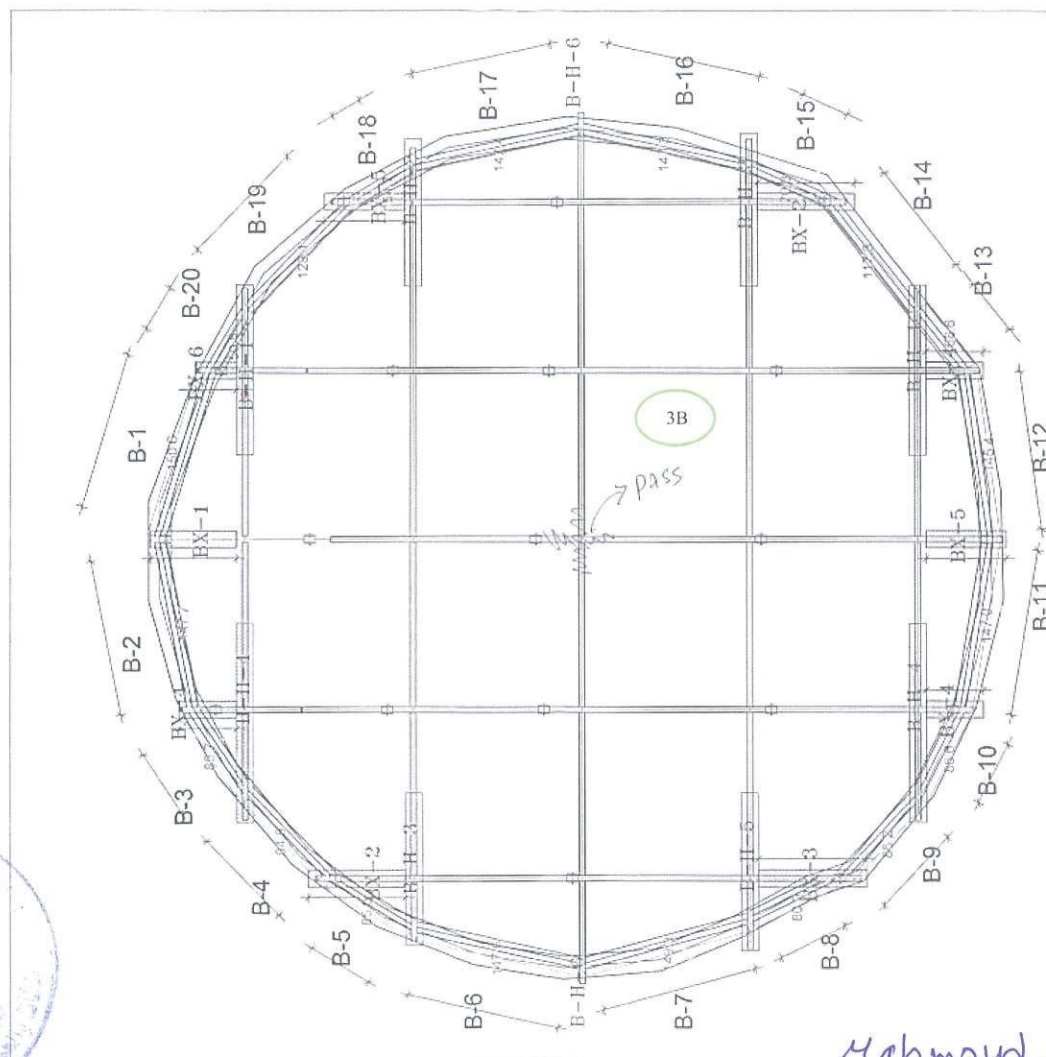
## Building B (Sky light )

| Building | plan/roof | Position (axis) | Room NO | Results |
|---|---|---|---|---|
| | Sky light | 3B | - | Pass |

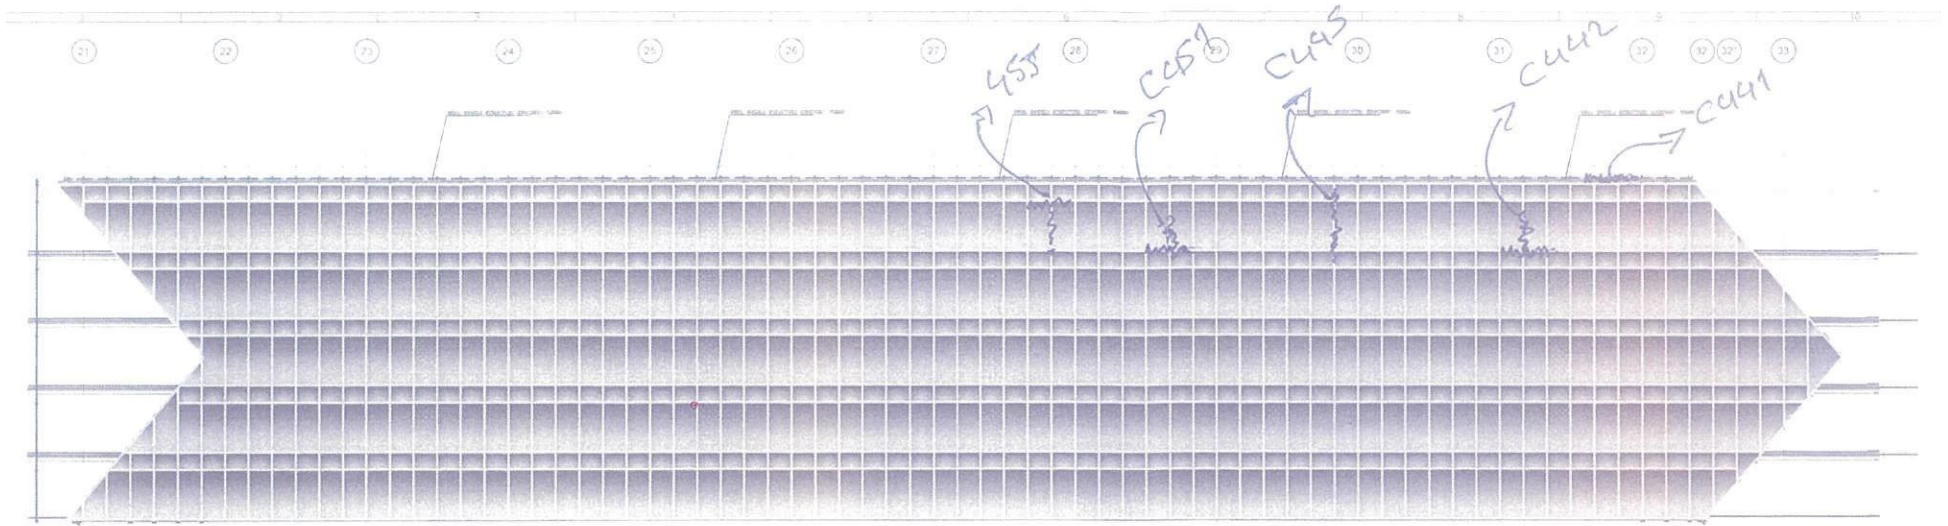
## Building C (Front view )

| Building | Elevation/roof | Floor | Position (axis) | Room NO | Results |
|---|---|---|---|---|---|
| C | Front | 4 | 27-28 | 455 | Pass |
| | | | 28-29 | 451 | Pass |
| | | | 29-30 | 445 | Pass |
| | | | 30-31 | 442 | Pass |
| | | | 31-32 | 441 | Pass |

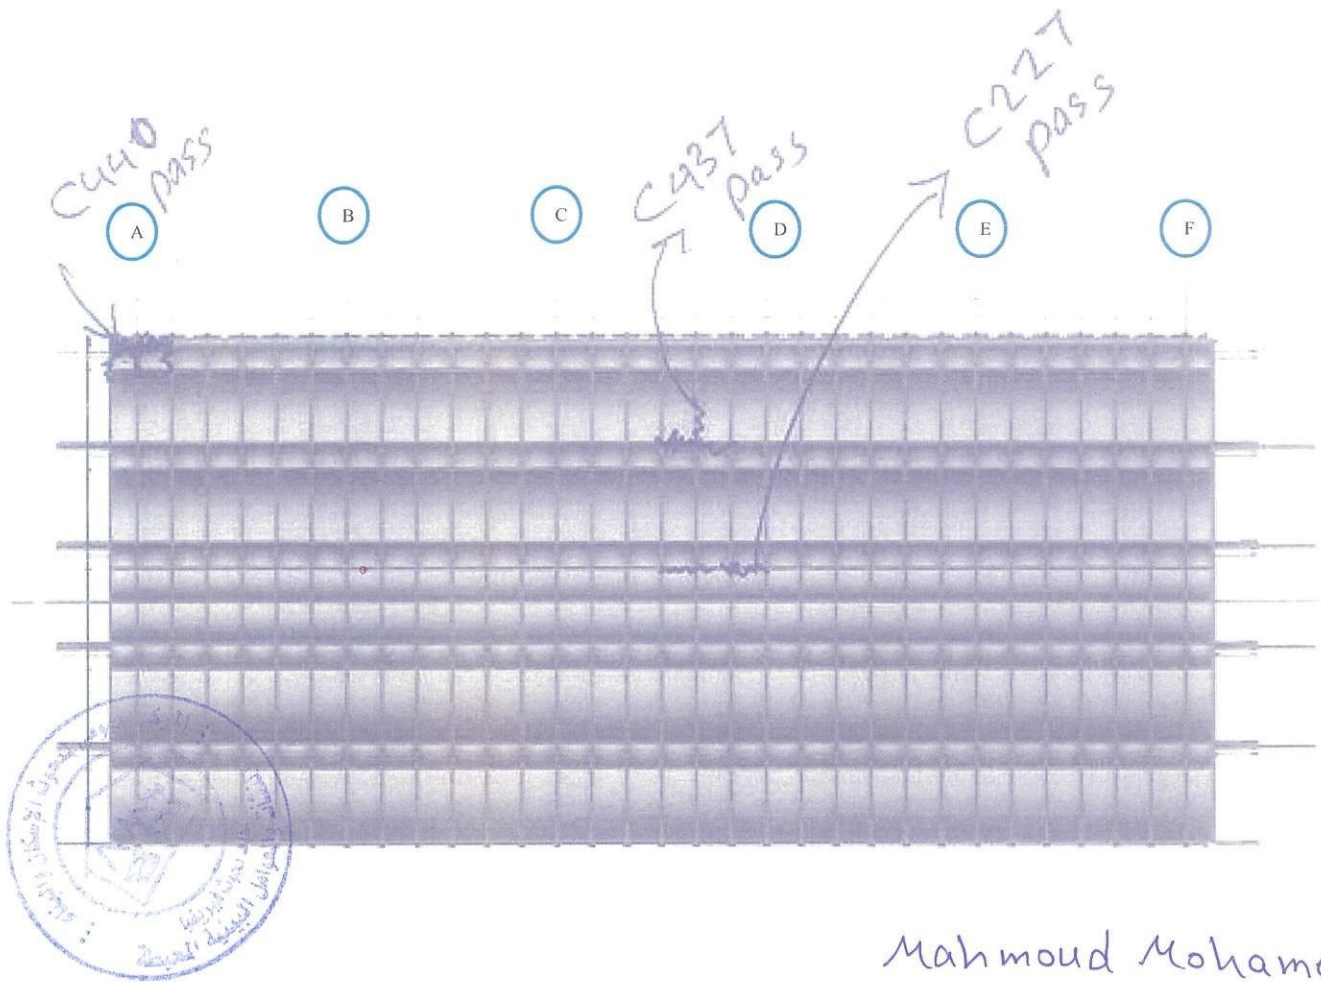
## Building C (Side view )

| Building | Elevation/roof | Floor | Position (axis) | Room NO | Results |
|---|---|---|---|---|---|
| | Side | 4 | A | 440 | Pass |
| | | | C-D | 437 | Pass |
| | | 2 | C-D | 227 | Pass |

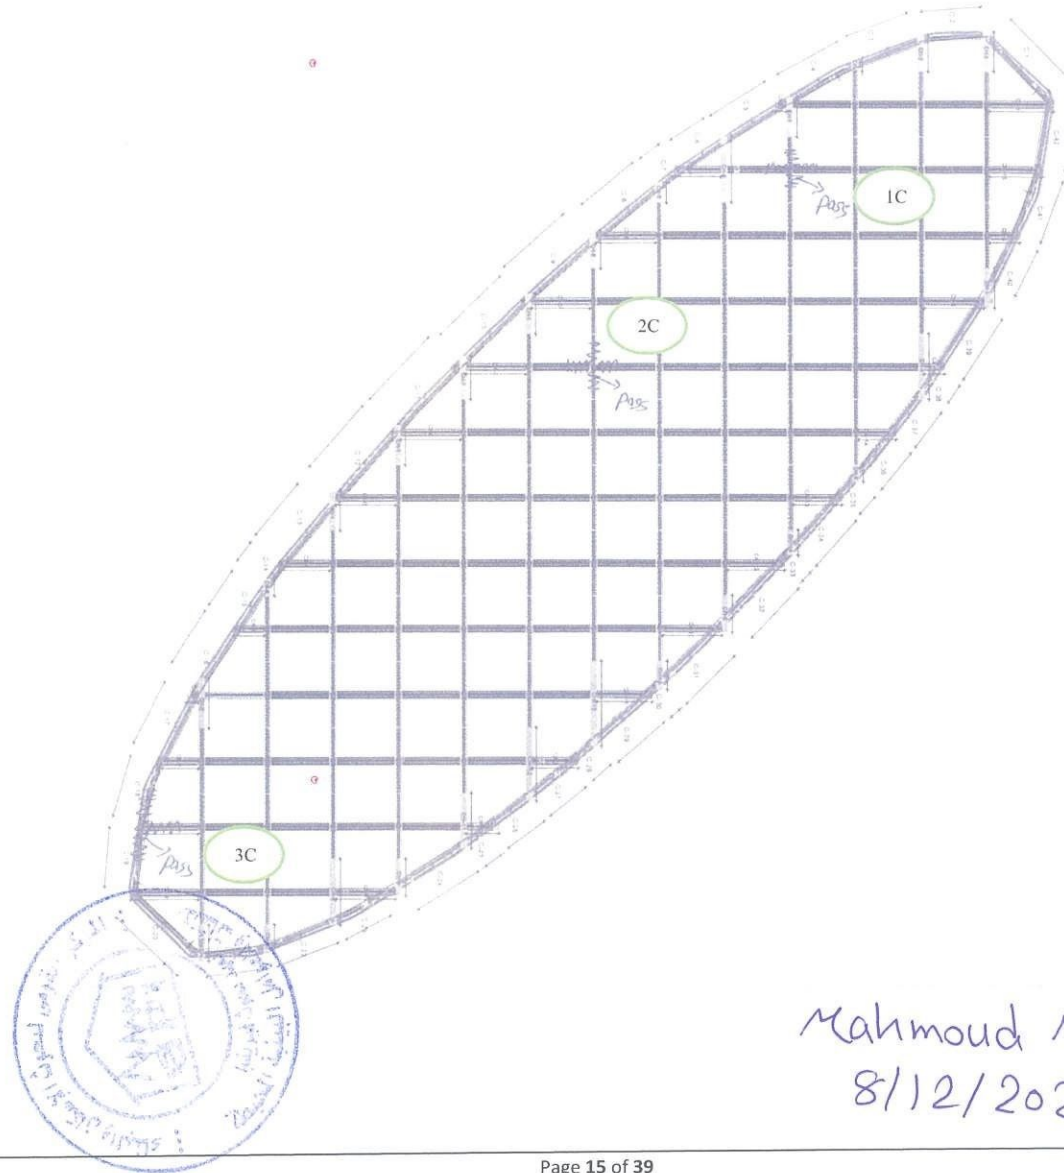
## Building C (Sky light )

| Building | Elevation/roof | Floor | Position (axis) | Room NO | Results |
|---|---|---|---|---|---|
| | Sky light | | 1C | - | Pass |
| | | | 2C | - | Pass |
| | | | 3C | - | |

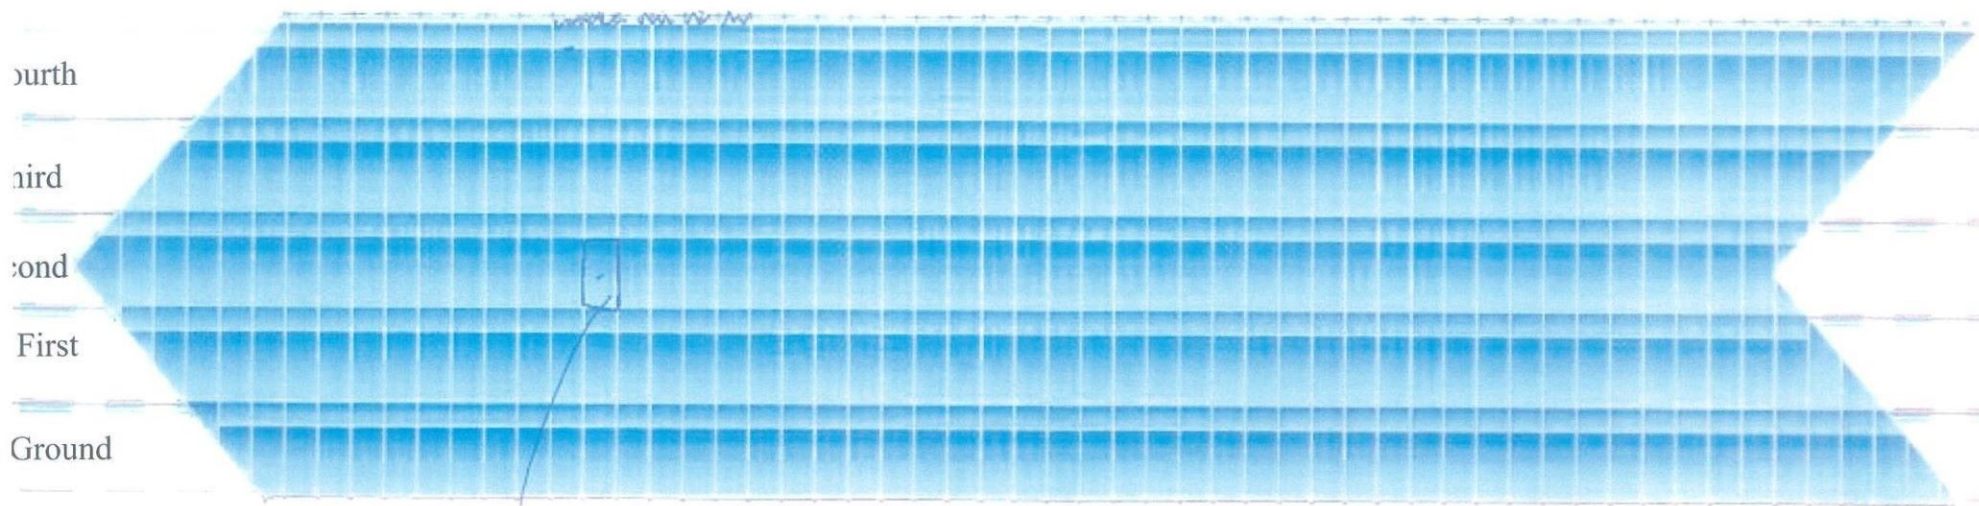
air test  
AZ16

| Test name | pressure, Pa | Floor | Position | Room No. | Result, L/S $m^2$ | Status |
|---|---|---|---|---|---|---|
| Air leakage | 75 | second | Axis (07-08) | A 216 | 0.078 | Pass |
