# FINAL REPORT

## SITE CHAMBER TEST – STRUCTURAL PERFORMANCE TEST

Testing of Declined Curtain wall - Petrobel Headquarters

## TESTING OF DECLINED CURTAIN WALL - PETROBEL HEADQUARTERS

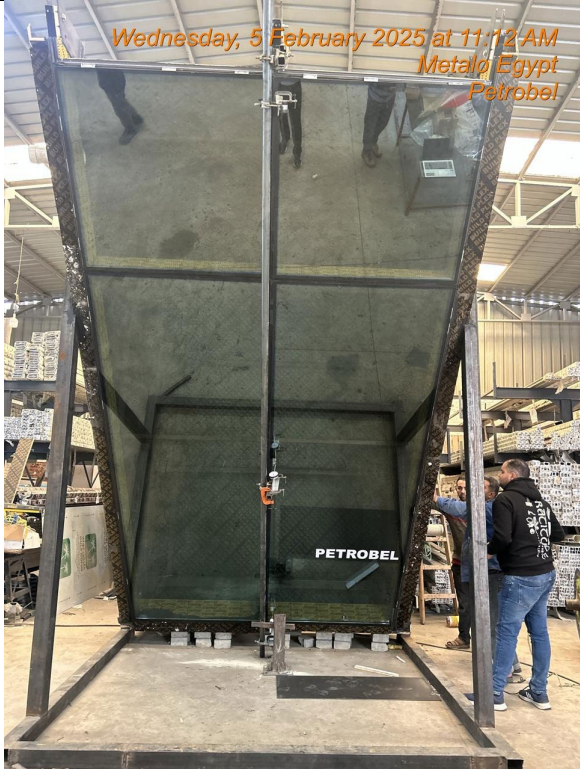
| Photo No. | Description | Photograph |
|---|---|---|
| 1 | External View of test specimen | |

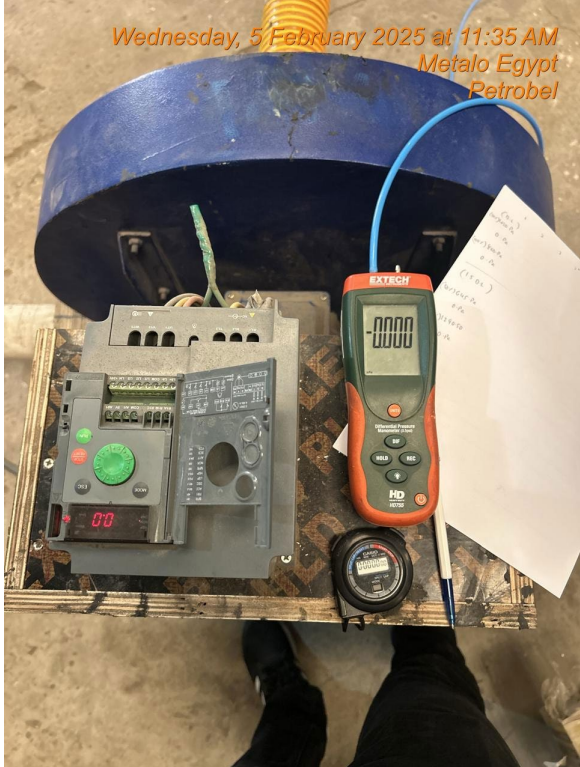
| Photo No. | Description | Photograph |
|---|---|---|
| 2 | Site chamber test set-up<br>Manometer and controller to regulate and monitor test pressure | |

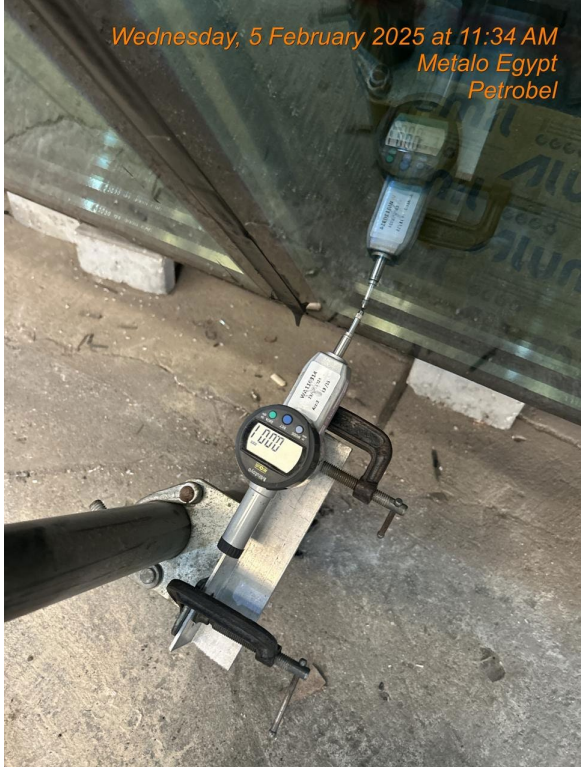
| 3 | Dial gauge set-up to record deflection of framing member | <p>Wednesday, 5 February 2025 at 11:34 AM<br/>Metalo Egypt<br/>Petrobel</p> |

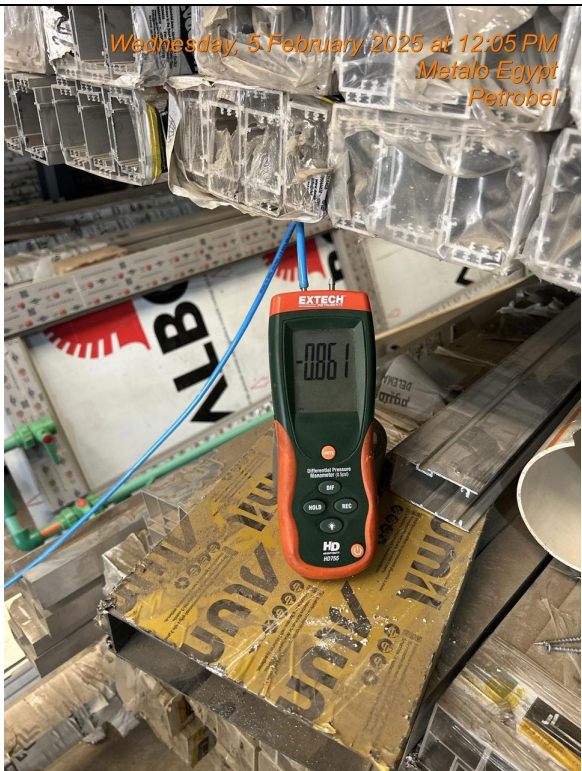
| 4 | Structural Performance Test loading in progress | <p>Wednesday, 5 February 2025 at 12:05 PM<br/>Metalo Egypt<br/>Petrobel</p> |

Both the positive and negative peak load deflections were within the allowable limits.

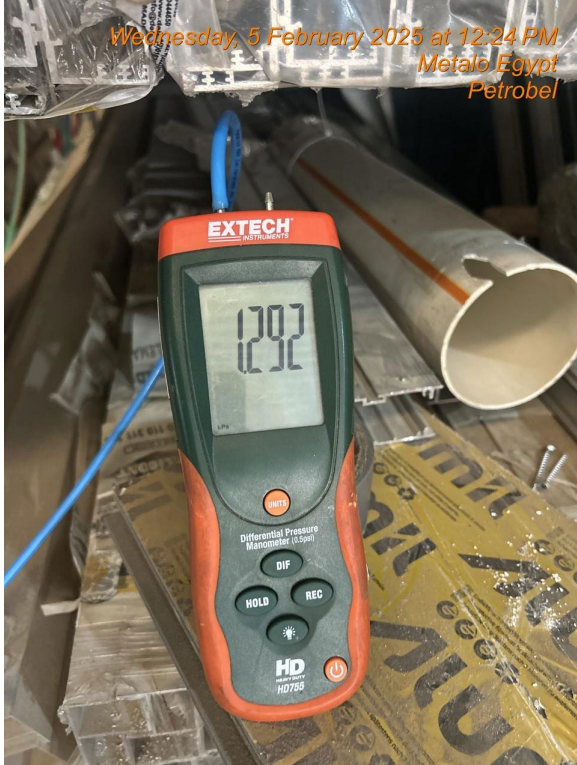
| 5 | Structural Proof Load Test in progress | |

No damage to the sample was visible.

Both the positive and negative residual deflections were within the allowable limits.
